FORM 1
CERTIFICATE OF SEISMIC PERFORMANCE LEVEL

Building Name: [DWP BLDG 2](#)
Address: [731 Charles E. Young Dr. S, Los Angeles CA 90095](#)
Site location coordinates: Latitude [34.0672582](#) Longitudinal [-118.4461552](#)

UCLA – DWP BLDG 2

FEMA 154 Rapid Visual Screening Minimum Building Report Information

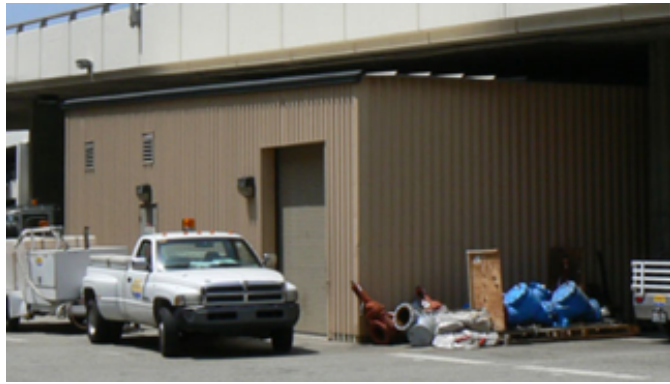
COMMENTS:
Equipment sits below a bridge previously rated as an IV structure. The building houses essential electrical equipment.
