**FORM 1**  
**CERTIFICATE OF SEISMIC PERFORMANCE LEVEL**

### UCLA – Easton Stadium (Bleacher Storage)

**FEMA 154 Rapid Visual Screening**

Building Name: **Easton Stadium - Bleacher Storage**

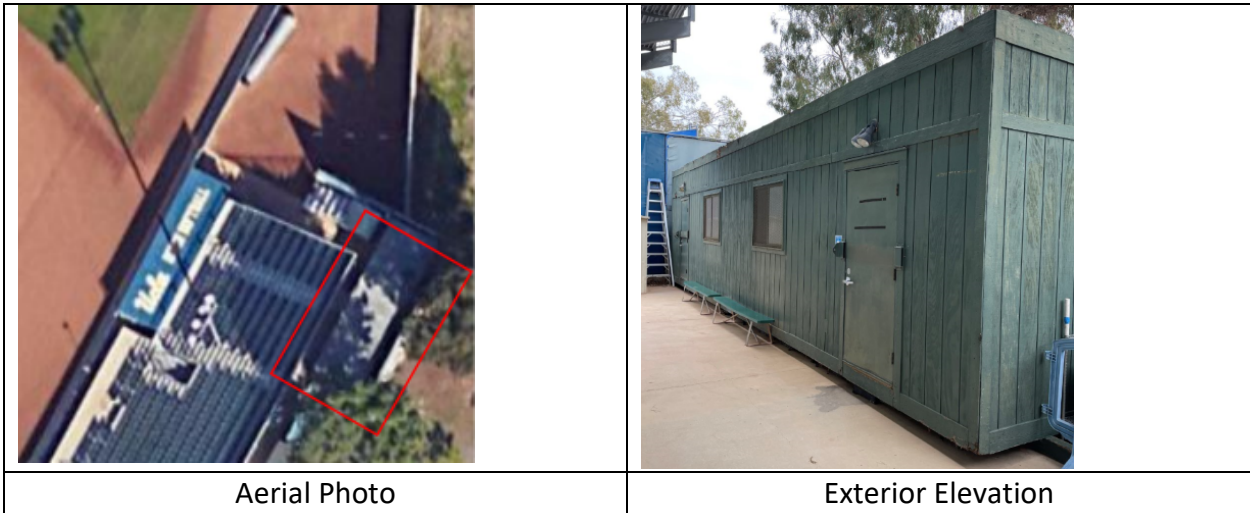
COMMENTS:  
Observed exterior of modular unit. Unit is not anchored to the slab below and rests on top of wood members.  
 Additional sketches or comments on separate page
