FORM 1
CERTIFICATE OF SEISMIC PERFORMANCE LEVEL

Building Name: [Easton Stadium - Outfield Storage](#)
Address: [100 De Neve Dr. Los Angeles, CA 90024](#)
Site location coordinates: Latitude [34.07389225](#) Longitudinal [-118.4424168](#)

UCLA – Easton Stadium (Outfield Storage)

FEMA 154 Rapid Visual Screening

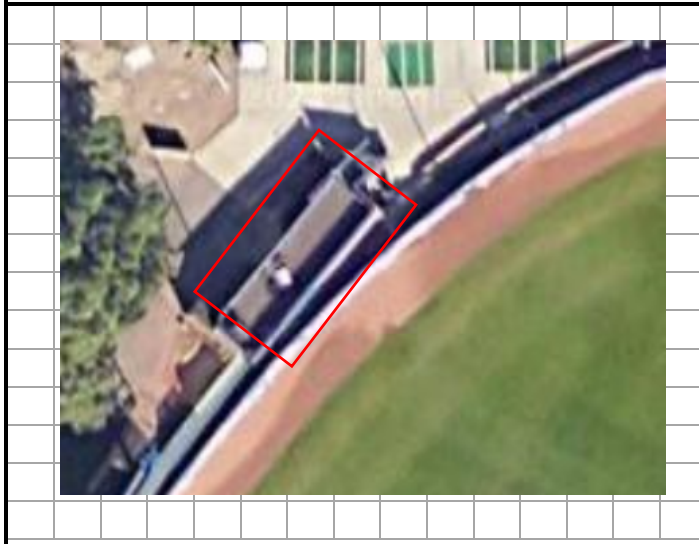
SKETCH

COMMENTS:
Both the exterior and the interior of the modular unit was inspected. The unit is not anchored to slab below.
