**ASCE 41-17 Tier 1 Seismic Evaluation**

**DATE:** 5/18/2021  
**UC Campus:** UCLA  
**Building Name:** 6 Schoenberg – Herb Alpert Teaching/Organ Studio Building  
**CAAN ID:** 4335.3  
**Auxiliary Building ID:** 4335, 4335.1, 4335.2

**SUMMARY OF INFORMATION PROVIDED BY EVALUATOR:** **THORNTON TOMASETTI**

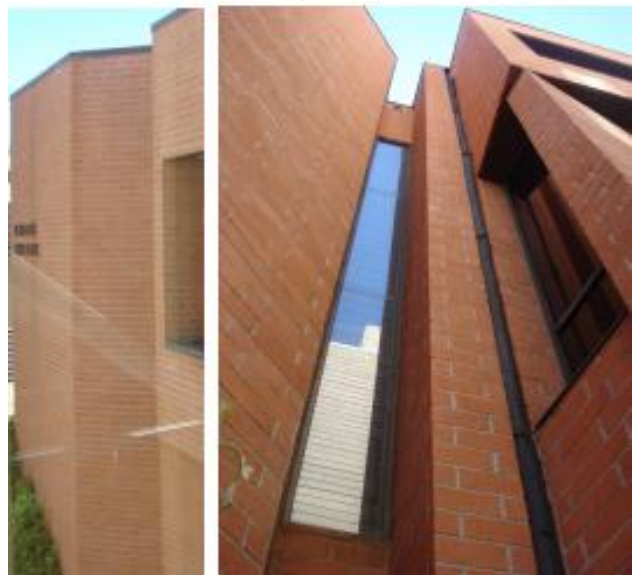
*Left: West Elevation, Right: Seismic Joint*

Seismic joint in wall at ground floor level (West side of building) in need of review and/or replacement cover.
