ASCE 41-17 Tier 1 Seismic Evaluation

DATE: 5/18/2021
UC Campus: UCLA
Building Name: Schoenberg – Scene Shop Building
CAAN ID: 4335.1
Auxiliary Building ID: 4335, 4335.2, 4335.3

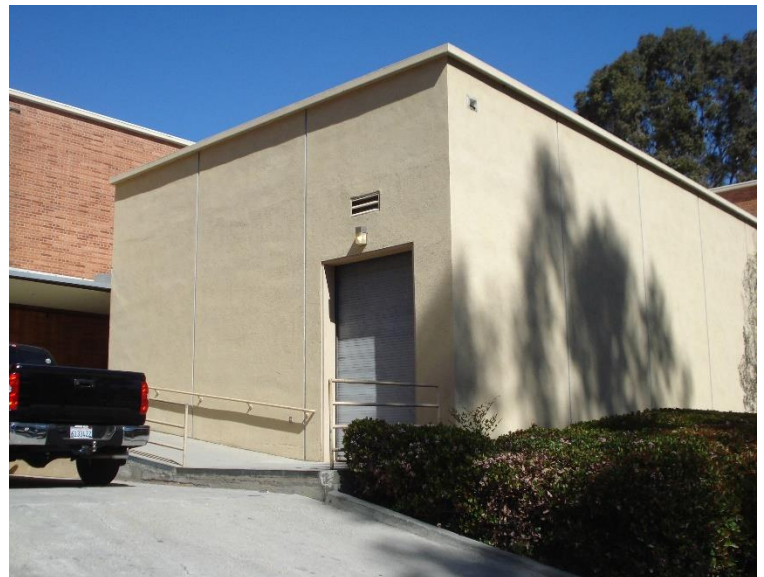
Exterior Elevation Photo – South and East sides

DEFECTS AND DETERIORATION: There were no signs of defects or deterioration noted during the visual observation. In general, the building appeared to be in good condition.
