FORM 1
CERTIFICATE OF SEISMIC PERFORMANCE LEVEL

Building Name: [Sunset Canyon Recreation Center – Main Office & Conference Center](#)
Address: [111 Easton Drive](#)
Site location coordinates: Latitude [34.075283](#) Longitudinal [-118.451105](#)

UCOP SEISMIC PERFORMANCE LEVEL (OR “RATING”): IV

Original Structural Drawings:
Seismic Evaluation: [Structural Evaluation of UCLA Sunset Canyon Recreation Center, Nabih Youssef Associates, June 27, 2014, ASCE 31/Tier 1](#)
Retrofit Structural Drawings:

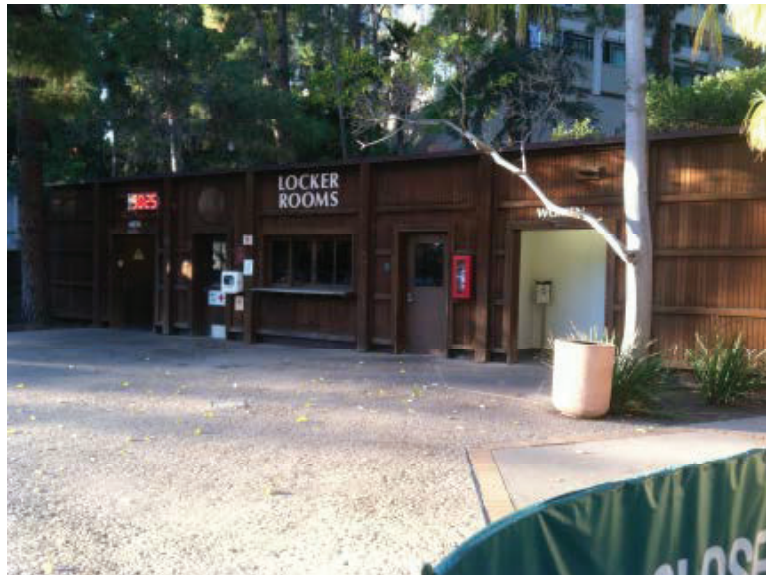
Photo 2.1: Building A

The concrete walls provide the primary lateral resisting system for the structure. Although a secondary lateral system is required on the south side, the existing wall siding provides some level of seismic resistance to that side of the structure. Based on the structural analysis and the assumption that the connections of the primary lateral force resisting system have not been adversely affected by wood deterioration the UC Seismic Rating for this building is **III/IV (three/four)**.

Building A is a single story hexagonal shaped building approximately 2600 sf in plan. Photo 2.1 depicts the north elevation of the structure.

- The wood roof sheathing acts as a structural diaphragm that transfers seismic inertial forces to vertical resisting elements.
- The concrete retaining wall on the south provides the primary vertical resisting system on 3 sides of the structure. The north side appears to lack a structural resisting system, however, the exterior wood siding and interior wall finishes do provide some level of seismic resistance.

In order to improve the seismic performance of the structure we recommend that plywood sheathing be applied either to the interior or exterior face of the south wall and new uplift anchors be added at each end of the new wall. Due to observed roof damage, exposure and inspection of the connection between the top of the concrete wall and the wood roof framing is recommended.

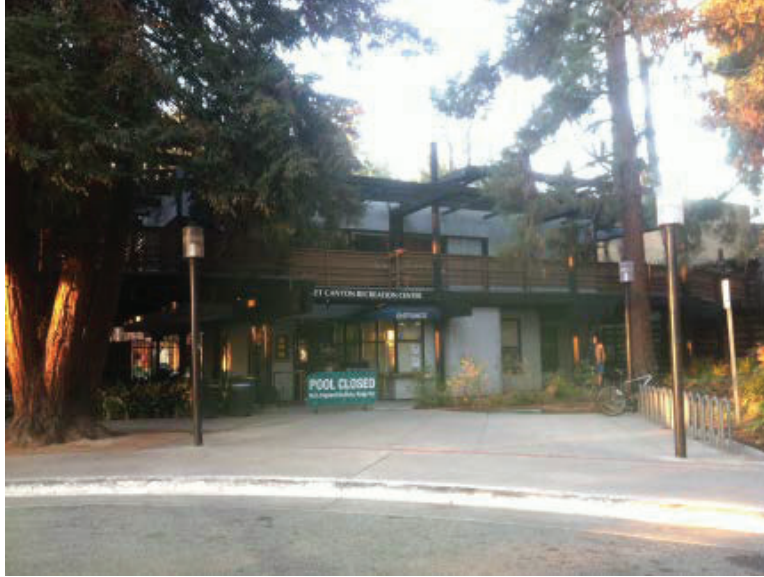
Photo 2.2: Building B

Deficiencies in this structure include: 1) the lack of continuity between the upper level shearwalls and the lower level walls, and 2) Insufficient amount of shear wall length at each floor.

The existing structure has a continuous load path and the existing plywood shearwalls provide some level of seismic resistance to the structure. Based on the structural analysis and the assumption that the connections of the primary lateral force resisting system have not been adversely affected by the wood deterioration the UC Seismic Rating for this building is **IV (four)**.

Building B is a two-story rectangular shaped building approximately 4000 sf in plan. Photo 2.2 depicts the north elevation of the structure.

- The floor and wood roof sheathing acts as a structural diaphragm that transfers seismic inertial forces to vertical resisting elements.
- At the 2nd floor, wood framed walls sheathed with 3/8" thick plywood at the perimeter of the structure provide the lateral resisting system of the building.
- At the first floor level, 3 - U-shaped walls sheathed with 3/8" plywood provide the lateral resisting system for the structure. The location of the walls on the upper and lower levels are not continuous.

In order to improve the seismic performance of the structure we recommend that the existing sheathed walls be resheathed with 1/2" plywood and the condition of the hold-down anchorage connections be investigated. Alternatively, new shearwalls can be provided to increase the strength capacity of the building.

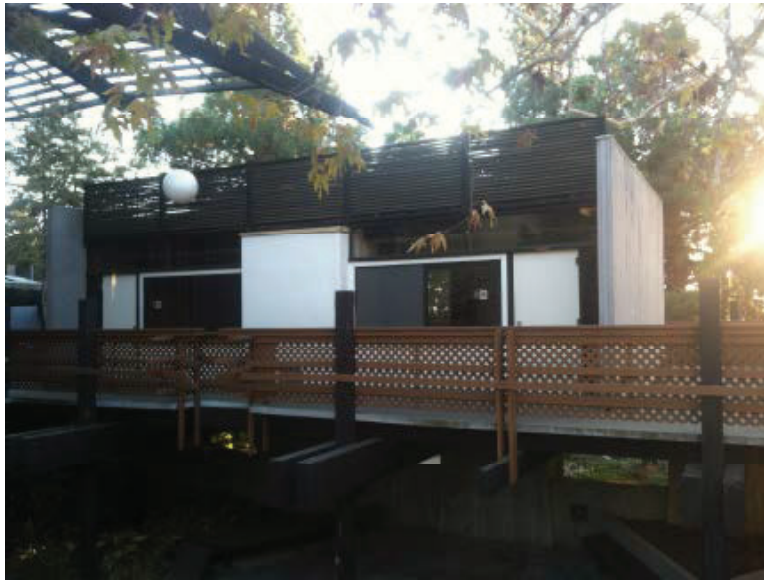
Photo 2.3: Building C

In addition, two gravity supporting posts on the north and south side were observed to have substantial deterioration at the Beam/Post connection which should be mitigated.

Based on the structural analysis and the assumption that the connections of the primary lateral force resisting system have not been adversely affected by the wood deterioration the UC Seismic Rating for this building is **V (five)**.

Building C is a single-story rectangular shaped building approximately 700 sf in plan. It sits above a concrete retaining wall, with open area below the main floor level. Photo 2.3 depicts the west elevation of the structure.

- Wood framed walls are braced in plane, on 3 sides with 1"x4" "let-in" diagonal wood bracing. The west elevation appears to lack a lateral resisting system, however a short 4'-0" length of wall with exterior wood siding can provide some level of seismic resistance.
- At the raised first floor, concrete retaining wall with thickened pilasters provides the lateral resisting system for the structure.

We recommend that support connections at the north and south side be mitigated as depicted in Figure 5.2.

Verification of the condition of the existing Beam to Concrete Wall Piers connections should be performed.

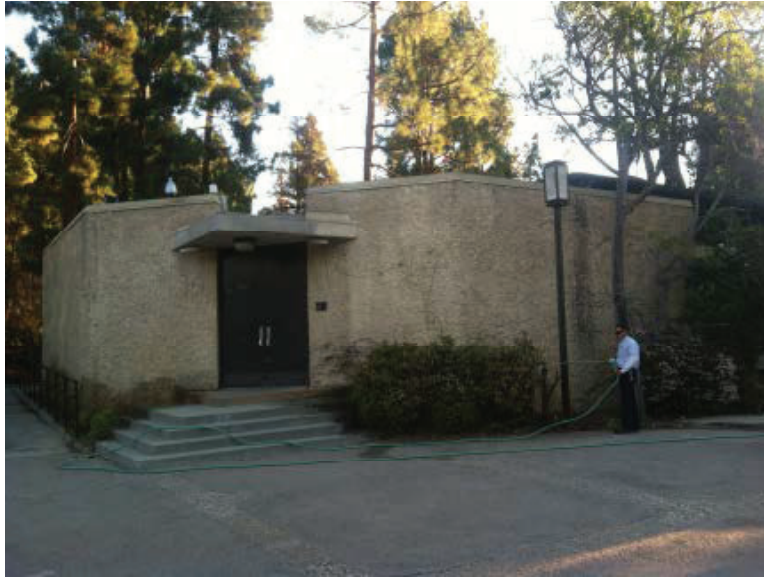
Photo 2.4: Building D

Due to the glass skylight openings around the perimeter of the building, the diaphragm to shearwall connection is inadequate.

Based on the structural analysis and the assumption that the connections of the primary lateral force resisting system have not been adversely affected by the wood deterioration the UC Seismic Rating for this building is **IV (four)**.

Building D is a single story octagonal shaped building approximately 2400 sf in plan. Photo 2.4 depicts the west elevation of the structure.

- The wood roof sheathing acts as a structural diaphragm that transfers seismic inertial forces to vertical resisting elements.
- The exterior wood framed walls with 3/8" thick sheathing provide the primary vertical resisting system the perimeter of the structure.

We recommend that the diaphragm to wall connection be strengthened to be able to deliver the seismic inertial forces to the exterior walls. This can be done by adding steel struts between the skylight openings in place of the existing wood bracing.

Verification of the condition of the existing hold-down anchors at the wall ends should be performed.

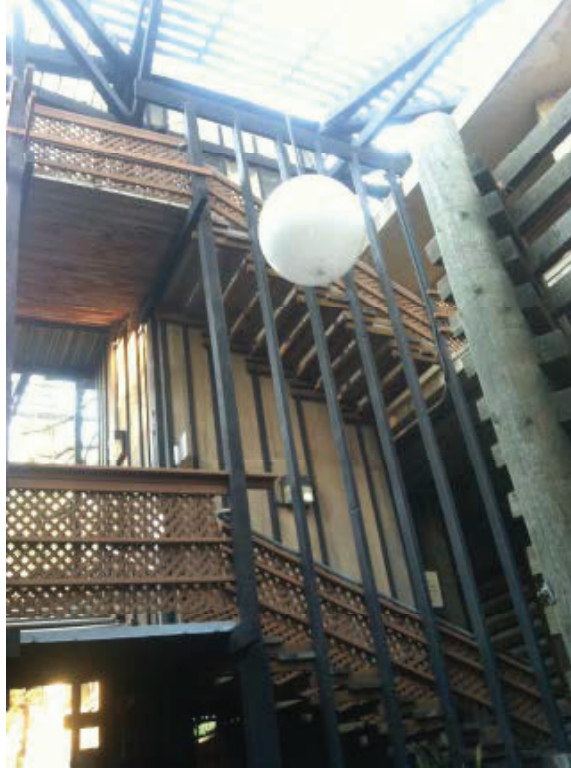
Photo 2.5: Building E

This stair structure is seismically connected to Building D. However, the main deficiency in this building includes the lack of lateral resisting system on the south side of the structure to resist east/west seismic inertial forces.

Based on the structural analysis and the assumption that the connections of the primary lateral force resisting system have not been adversely affected by the wood deterioration the UC Seismic Rating for this building is **IV (four)**.

Building E is a 3-level stair structure that connects the upper, middle, and upper levels of the sloped site. Photo 2.5 depicts the north elevation of the structure.

- The roof and floor landing levels are laterally connected to the Building D roof and floor slab to resist out-of-plane seismic loads and in-plane loads on the west side.
- The east elevation does not have a vertical resisting system for loads in the north/south direction.

We recommend that a seismic resisting element be provided to the south elevation. This can consist of a series of diagonal steel rods between floors, down to the foundation.

Verification of the condition of the connecting elements between the roof of Building D and E

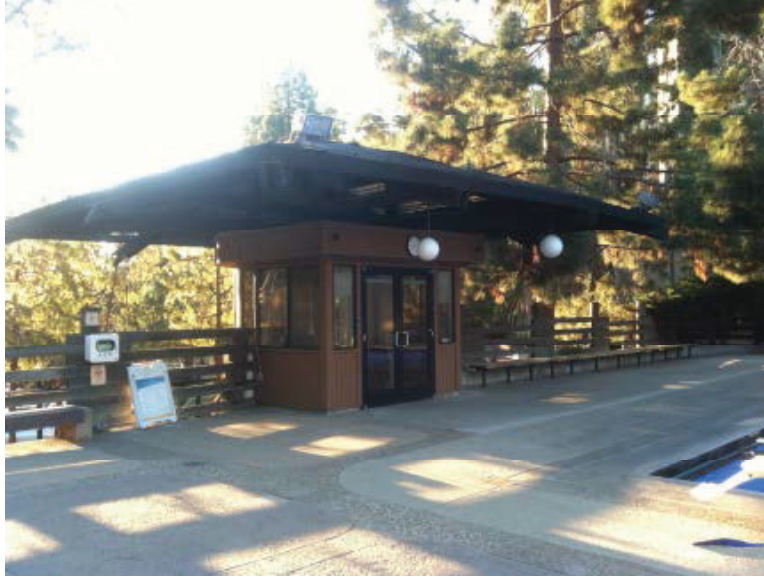
Photo 2.6: Building F

Building F is a single story rectangular shaped building approximately 100 sf in plan. The structure is constructed within a Pop-Up wood trellis. The pop-up roof measures approximately 900 sf in plan. Photo 2.6 depict the west elevation of Building F.

- The wood roof sheathing above the office enclosure acts as a structural diaphragm to transfer seismic inertial forces to vertical resisting elements.
- The 4 wood posts of the trellis provide some level of seismic resistance to the trellis roof. The detailing is such that the wood posts and beams can behave as a wood frame to resist seismic inertial forces.

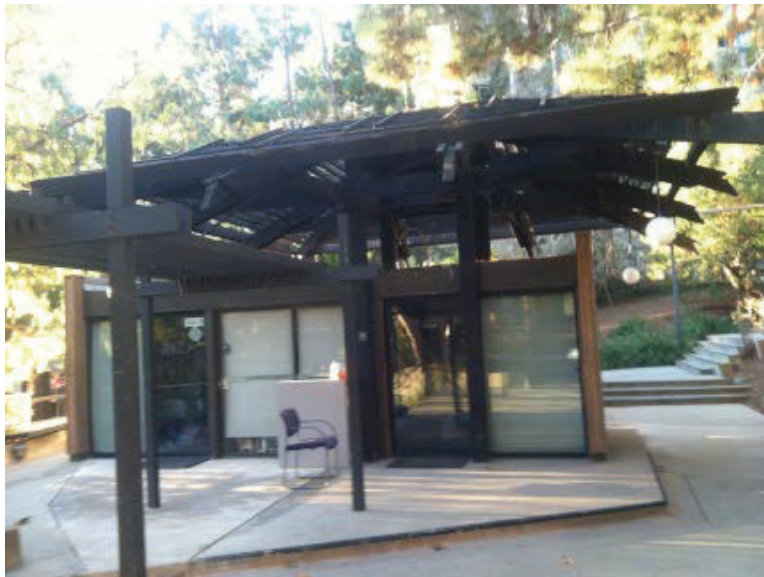
Photo 2.7: Building G

Building G is a single story rectangular shaped building approximately 128 sf in plan. The structure is constructed below a Pop-Up wood trellis. The wood pop-up roof trellis measures approximately 570 sf in plan. Photo 2.7 depicts the north elevation of Building G.

- The diagonal wood struts and tension rods act as a horizontal truss to transfer seismic inertial forces to the vertical resisting elements.
- The wood roof sheathing above the offices acts as a structural diaphragm to transfer seismic inertial forces to vertical resisting elements.
- The 4 wood posts of the trellis provide some level of seismic resistance to the trellis roof. The detailing is such that the wood posts and beams can behave as a wood frame to resist seismic inertial forces.
- On three sides of the offices, wood shearwalls provide the primary lateral resisting system of the structure. The north side of the offices do not appear to have a lateral resisting system.

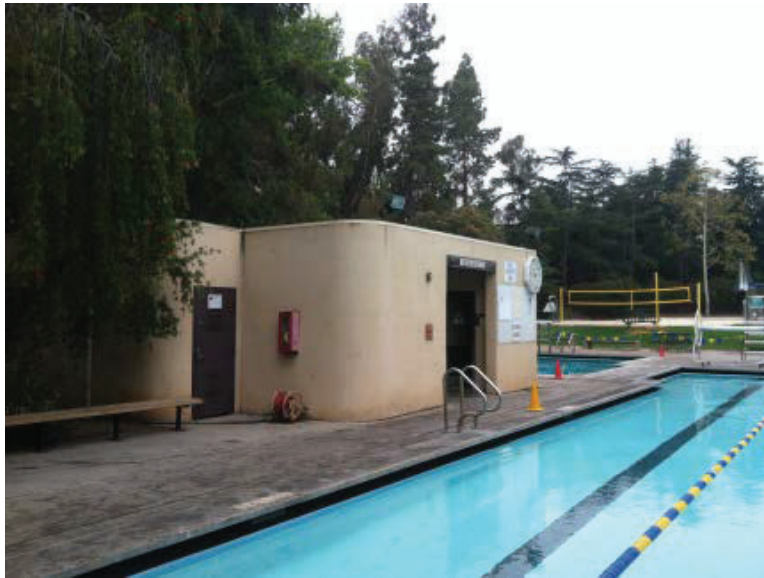
Photo 2.8: Building H

- The wood roof sheathing acts as a structural diaphragm to transfer seismic inertial forces to vertical resisting elements.
- On four sides of the structure, wood shearwalls provide the primary lateral resisting system of the structure.

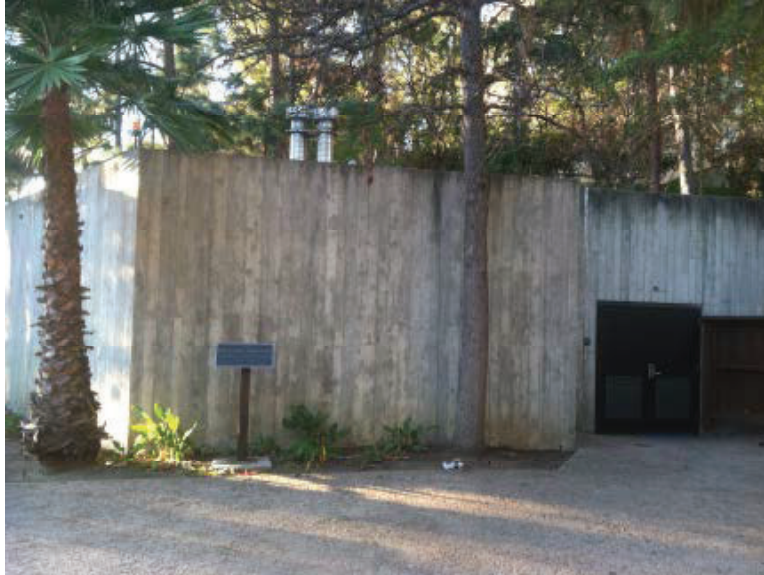
Photo 2.8: Building P

Building P is a single story hexagonal shaped building approximately 1100 sf in plan. Photo 2.8 depicts the north elevation of the building.

- The perimeter concrete retaining walls provides the vertical resisting system of the structure.
