Campus: [UCLA](#)
Building Name: [Transit Operations Center](#)
CAAN ID: [4522](#)
Auxiliary Building ID:

FORM 1
CERTIFICATE OF SEISMIC PERFORMANCE LEVEL

ASCE 41-17 Tier 1 Seismic Evaluation
Minimum Building Report Information

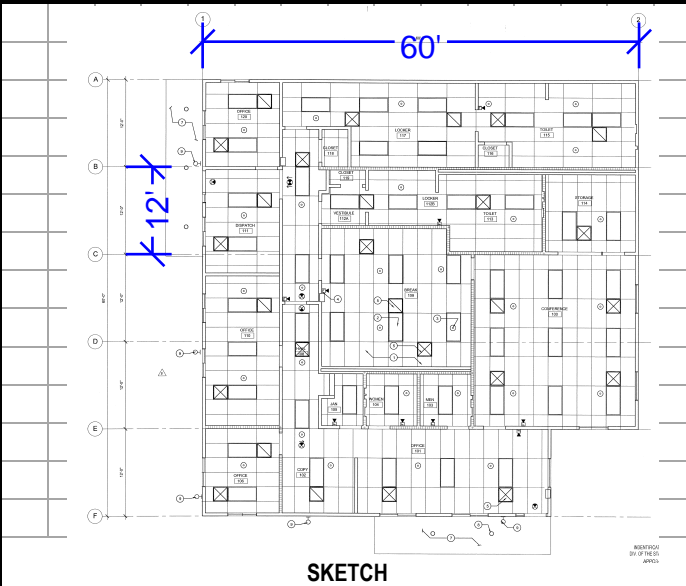
SKETCH

COMMENTS:
 Observed inside and outside of structural. No anchorage to supporting curb at base rails of modular trailers observed in field investigation

Add anchorage to prevent building from sliding off foundation.
