FORM 1
CERTIFICATE OF SEISMIC PERFORMANCE LEVEL

UCLA Lab School 1 – Classroom

ASCE 41-17 Tier 1 Seismic Evaluation
Minimum Building Report Information

Building Name: [Lab School 1 - Classroom](#)

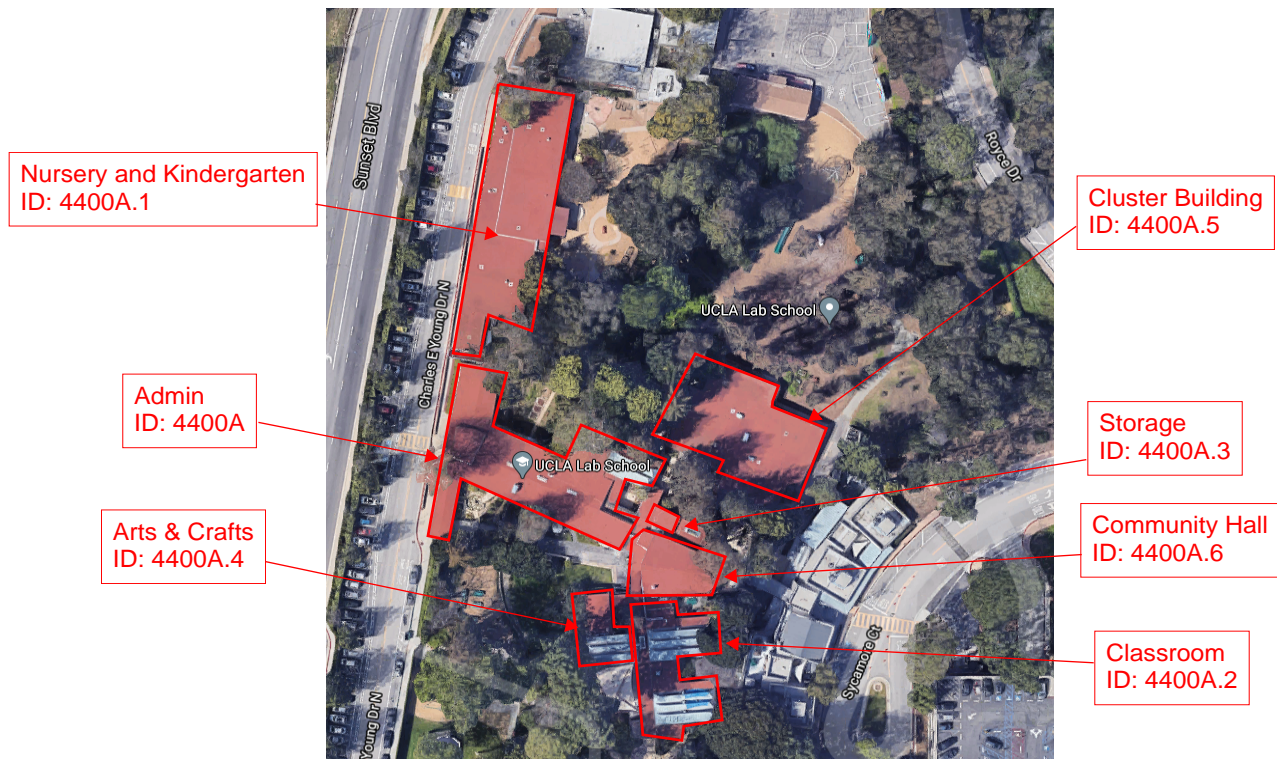
Figure 1 Key Plan of the Lab School 1 complex

The Lab School 1 complex is composed of multiple buildings. Each building is separated by several seismic separations allowing the different segments of the complex to act independently of one another. Shown below is a key plan of the complex along with the distribution of Building ID's at the complex.
