Campus: [UCLA](#)  
Building Name: [LAB 1 Comm Hall](#)  
CAAN ID: [4400A](#)  
Auxiliary Building ID: [4400A.6](#)

**FORM 1**  
**CERTIFICATE OF SEISMIC PERFORMANCE LEVEL**

### UCLA Lab School 1 – Community Hall

ASCE 41-17 Tier 1 Seismic Evaluation  
Minimum Building Report Information

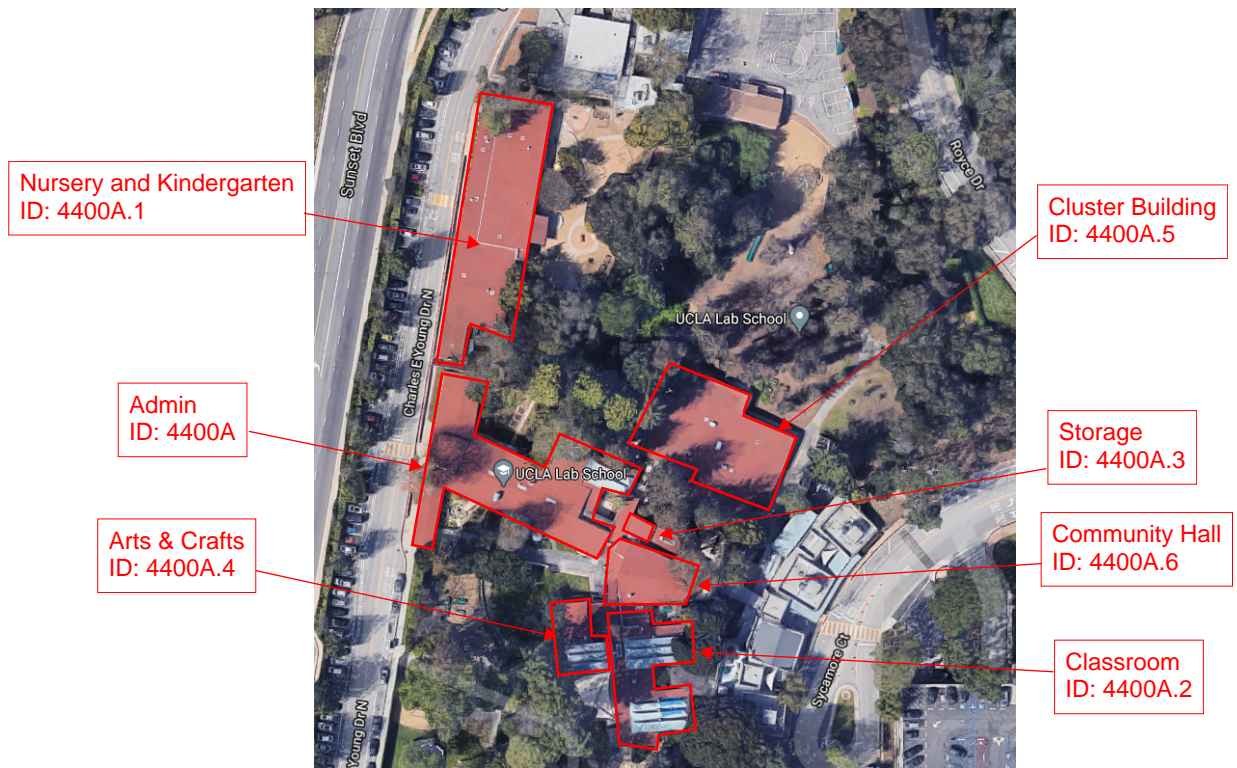
*Figure 1 Key Plan of the Lab School 1 complex*

The Lab School 1 complex is composed of multiple buildings. Each building is separated by several seismic separations allowing the different segments of the complex to act independently of one another. Shown below is a key plan of the complex along with the distribution of Building ID's at the complex.
