FORM 1
CERTIFICATE OF SEISMIC PERFORMANCE LEVEL

Building Name: Lab School 1: Storage
Address: 330 CHARLES E. YOUNG DRIVE, NORTH
Site location coordinates: Latitude 34.07538043 Longitudinal -118.4441833

UCLA Lab School 1 – Storage

**ASCE 41-17 Tier 1 Seismic Evaluation
Minimum Building Report Information**

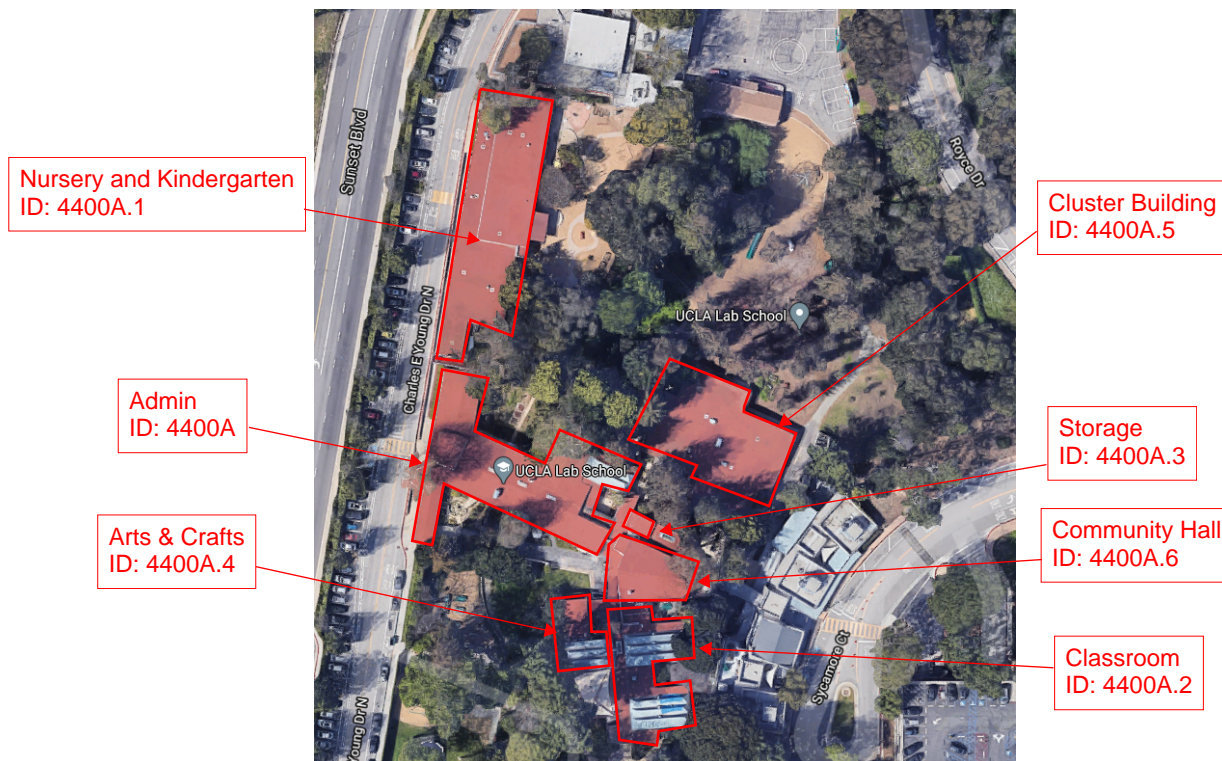
Figure 1 Key Plan of the Lab School 1 complex

The Lab School 1 complex is composed of multiple buildings. Each building is separated by several seismic separations allowing the different segments of the complex to act independently of one another. Shown below is a key plan of the complex along with the distribution of Building ID's at the complex.
