Campus: [UCLA](#)
Building Name: [1336 16th Street](#)
CAAN ID: [42172](#)
Auxiliary Building ID:

FORM 1
CERTIFICATE OF SEISMIC PERFORMANCE LEVEL

UCLA – 1336 16th Street

FEMA 154 Rapid Visual Screening

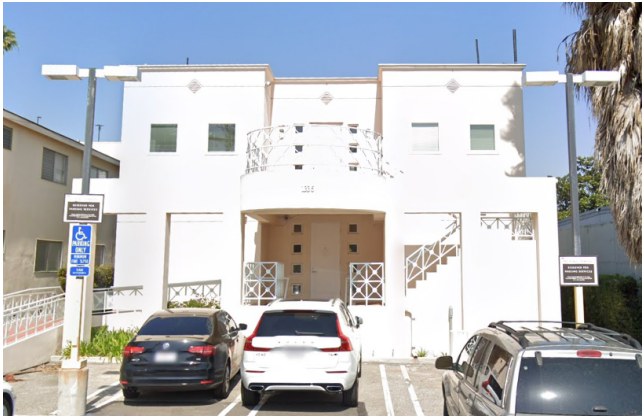
A. FEMA 154 Rapid Visual Screening

After further investigation, it is noted that the sill plates were anchored roughly 24" OC. It is also noted that the cripple walls were not sheathed and we therefore have a moderate vertical irregularity.

Add sheathing to cripple walls to provide better load path between shear walls and foundations.
