Campus: [UCLA](#)
Building Name: [Clark Library](#)
Support Facility – Filing (West)
CAAN ID: [4452B](#)
Auxiliary Building ID: [4452B.1](#)

FORM 1
CERTIFICATE OF SEISMIC PERFORMANCE LEVEL

Building Name: [Clark Library Support Facility - Filing \(West\)](#)
Address: [2520 Cimarron St. Los Angeles, CA 90018](#)
Site location coordinates: Latitude [34.03351687](#) Longitudinal [-118.3154301](#)

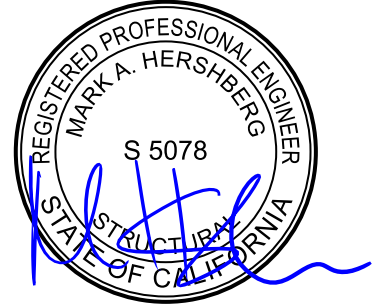
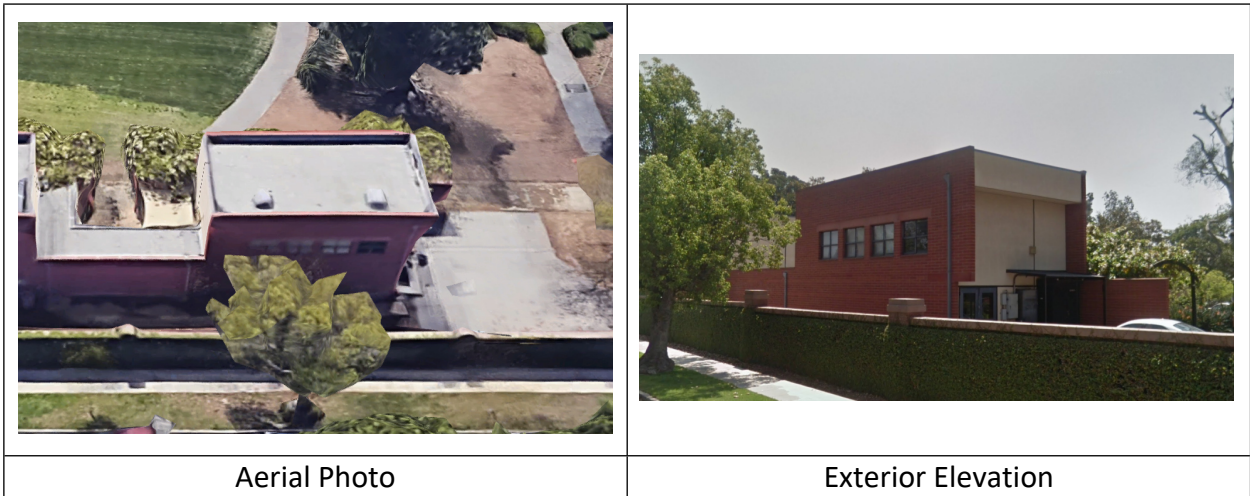
Address: 2520 Cimarron St. Los Angeles, CA 90018

Site location coordinates: Latitude 34.03351687 Longitudinal -118.3154301
