UCLA CENTER FOR HEALTH SCIENCES CYCLOTRON BUILDING

CONCEPTUAL RETROFIT RECOMMENDATION
APRIL 5th, 2012

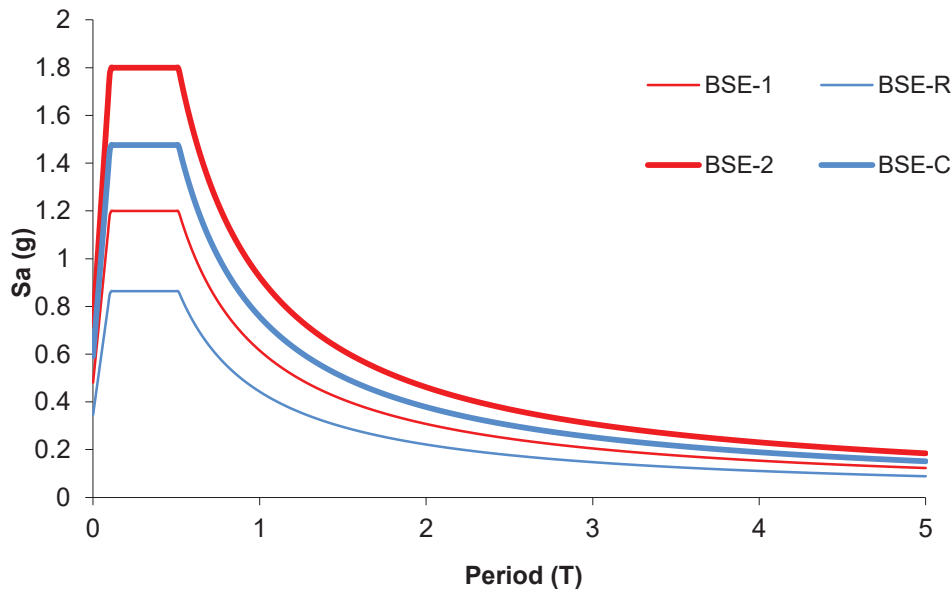
UCLA CHS ASCE 41 Response Spectrums

$$S_{XS} = 1.650g, \quad S_{X1} = 0.85g$$
