FORM 1
CERTIFICATE OF SEISMIC PERFORMANCE LEVEL

Building Name: [EQ Field](#)
Address: [39 Westwood Plaza Los Angeles, CA 90095](#)
Site location coordinates: Latitude [34.06981](#) Longitudinal [-118.446584](#)

Original Structural Drawings: ([N/A](#), [N/A](#), [N/A](#), [N/A](#)) or
Seismic Evaluation: ([EQ Field Seismic Evaluation, KPFF, 4/15/2021, FEMA 154 Rapid Visual Screening](#))
Retrofit Structural Drawings: ([N/A](#), [N/A](#), [N/A](#), [N/A](#))

FEMA 154 Rapid Visual Screening Minimum Building Report Information

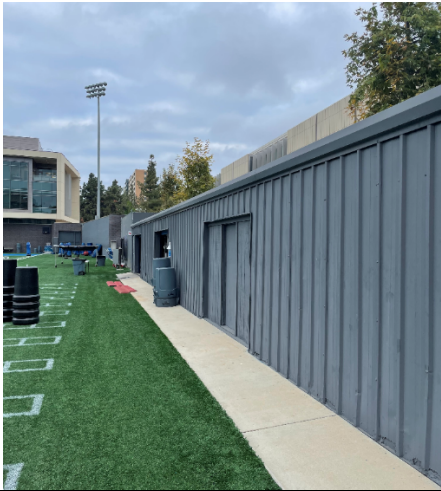
Address: 39 Westwood Plaza
Los Angeles, CA Zip: 90095

Other Identifiers: _____
 Building Name: EQ Field
 Use: _____
 Latitude: 34.06981 Longitude: -118.446584
 Ss: 2.036 S_r: 0.729
 Screener(s): _____ Date/Time: _____
