FORM 1
CERTIFICATE OF SEISMIC PERFORMANCE LEVEL

Building Name: Lab School 1: Administration Building
Address: 330 CHARLES E. YOUNG DRIVE, NORTH
Site location coordinates: Latitude 34.07538043 Longitudinal -118.4441833

ASCE 41-17 Tier 1 Seismic Evaluation
Minimum Building Report Information

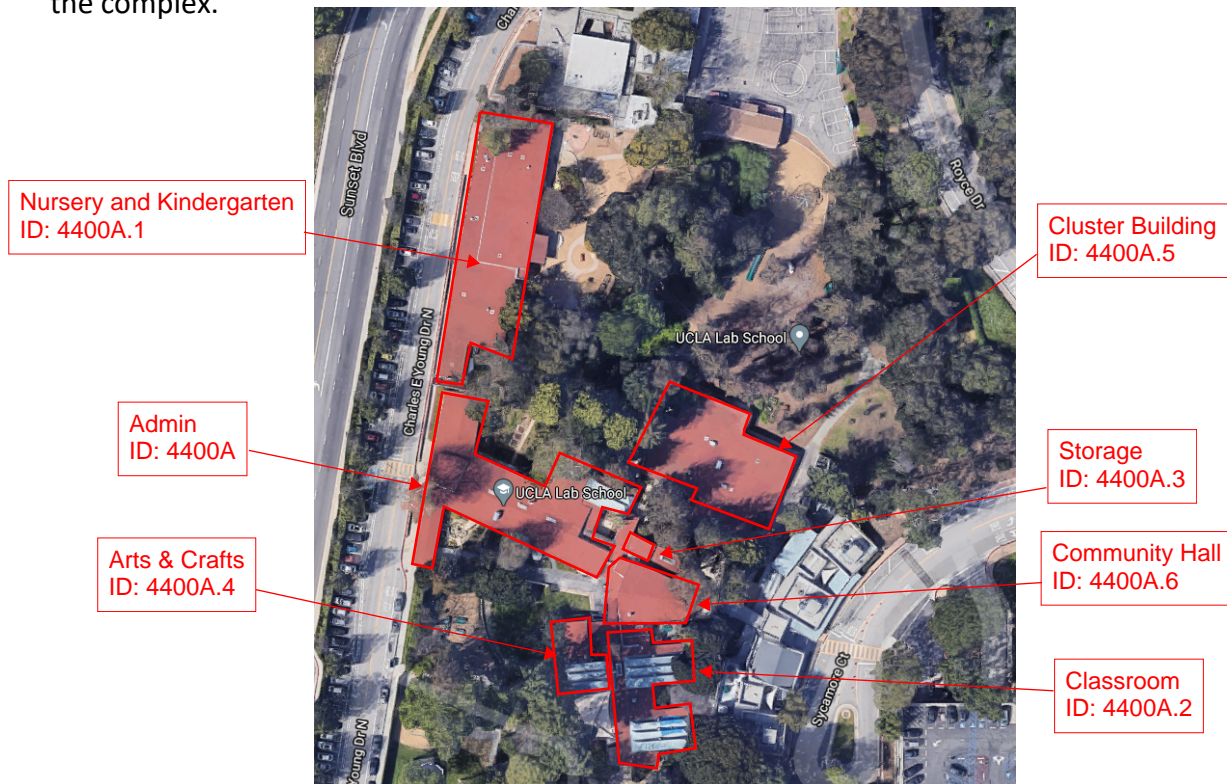
Figure 1 Key Plan of the Lab School 1 complex

The Lab School 1 complex is composed of multiple buildings. Each building is separated by several seismic separations allowing the different segments of the complex to act independently of one another. Shown below is a key plan of the complex along with the distribution of Building ID's at the complex.
