Seismic Reevaluation

Brain Research Institute Building Excerpt

UCLA Center for Health
Sciences
Los Angeles, California

June 25, 2007

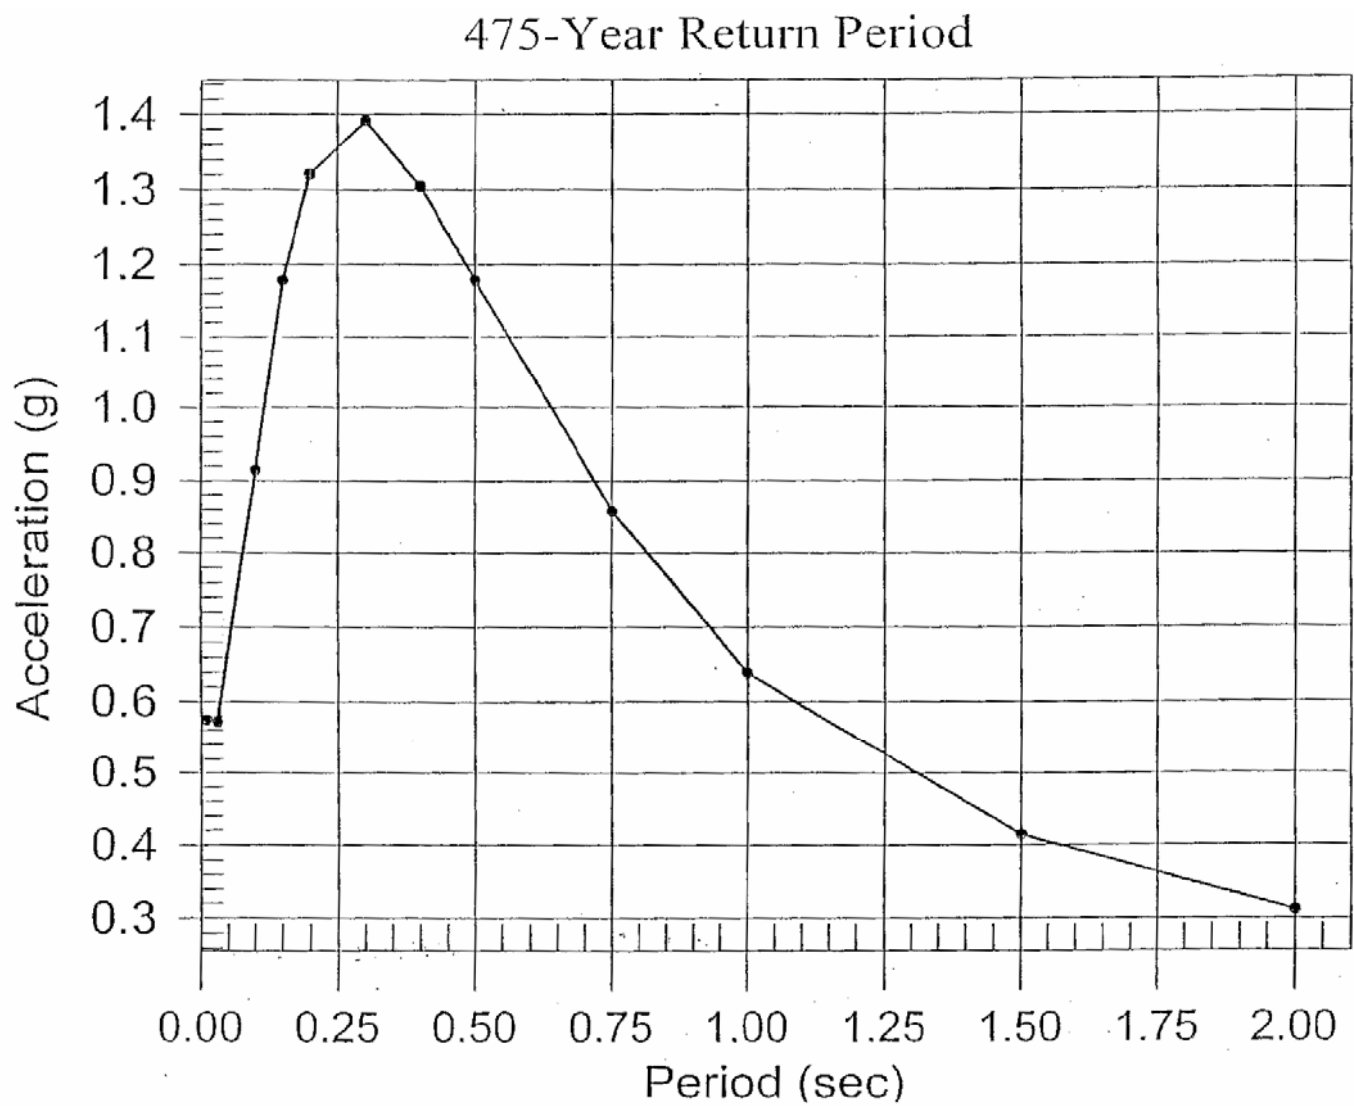
Response spectrum. 475-year estimated average return period. Reference: Geobase, Geotechnical report for J. Vernon Luck Sr. Research Laboratory, Project 204.23.01, 1999.

Coefficients used in the FEMA 356 method were $B_s = 1.0$, $B_1 = 1.0$, $S_{xs} = 1.26g$, $S_{x1} = 0.64g$, and $T_s = 0.508$ sec. For the purposes of this study, it is believed that this ground motion reasonably reflects the anticipated earthquake ground motion at the CHS site. The peer review confirmed this conclusion.
