UC Seismic Evaluation – 11500 W Olympic

Date: 06/24/2019
UC Campus: UCLA – off campus
Building Name: Olympic Plaza
Building Address: 11500 W Olympic Blvd, Los Angeles, CA 90064
CAAN ID: N/A
Auxiliary Building ID: N/A

Summary of information provided by Evaluator:
Nabih Youssef Associates Structural Engineers

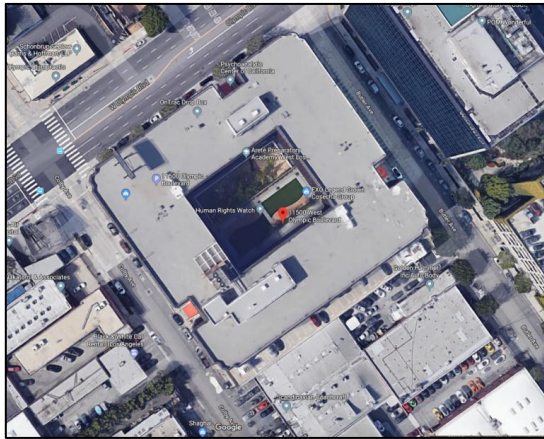
Plan Image or Aerial Photo

The 6-story office building has an area of approximately 244,500 square feet and was built in 1982. The building is irregular-shaped in-plan with re-entrant corners and a large opening in the floor diaphragms for an interior courtyard.
