Krieger CTR - B

DATE: 10/27/2020 ASCE 41-17 Tier 1 Seismic Evaluation Minimum Building Report Information

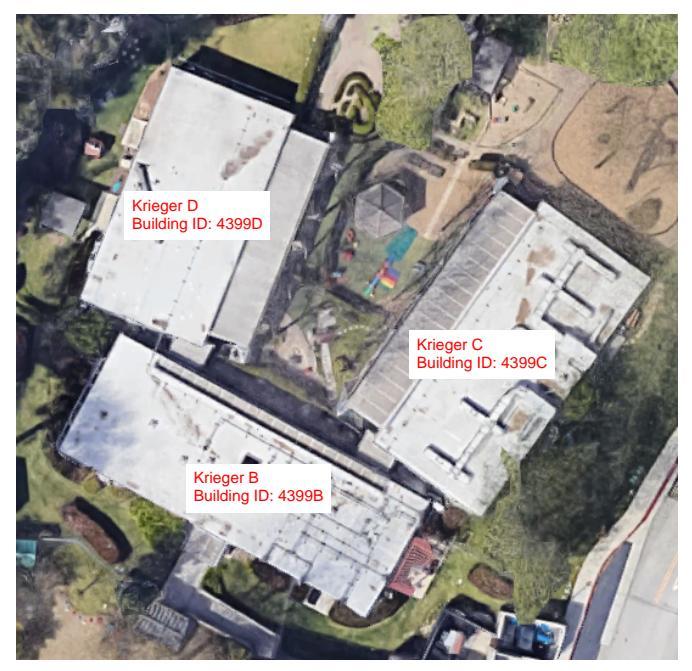
Figure 1 Key Plan of the Krieger CTR complex

The Kriger CTR complex is composed of three buildings. Shown below is a key plan of the complex along with the distribution of Building ID's at the complex.
