Krieger CTR - D

**ASCE 41-17 Tier 1 Seismic Evaluation
Minimum Building Report Information**

Building Name: [Krieger CTR-D](#)

Address: [101 Bellagio Drive, Los Angeles 90024](#)

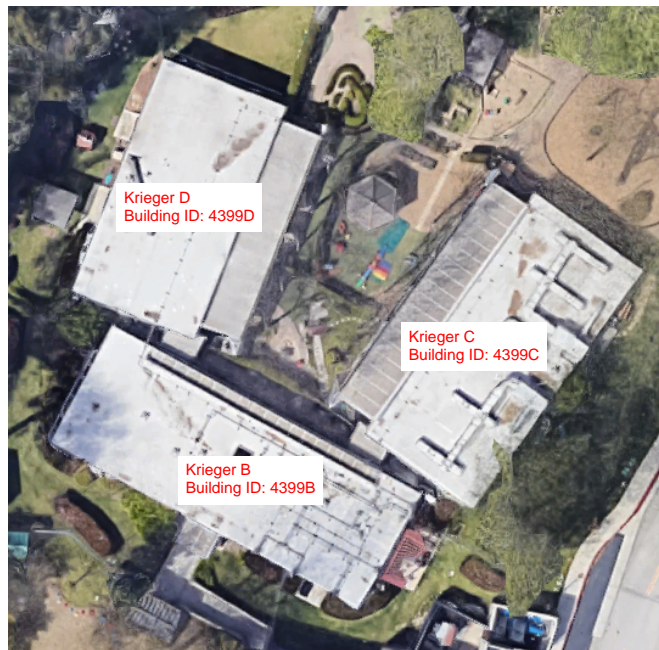
Figure 1 Key Plan of the Krieger CTR complex

The Kriger CTR complex is composed of three buildings. Shown below is a key plan of the complex along with the distribution of Building ID's at the complex.
